LAKE SALTONSTALL OUTLET  
MA-00164

NATIONAL DAM INSPECTION PROGRAM  
CORPS OF ENGINEERS

## LAKE SALTONSTALL OUTLET

Identification No.: MA 00164  
Stream: Tributary of Merrimack River  
Town: Haverhill  
County and State: Essex County, Massachusetts

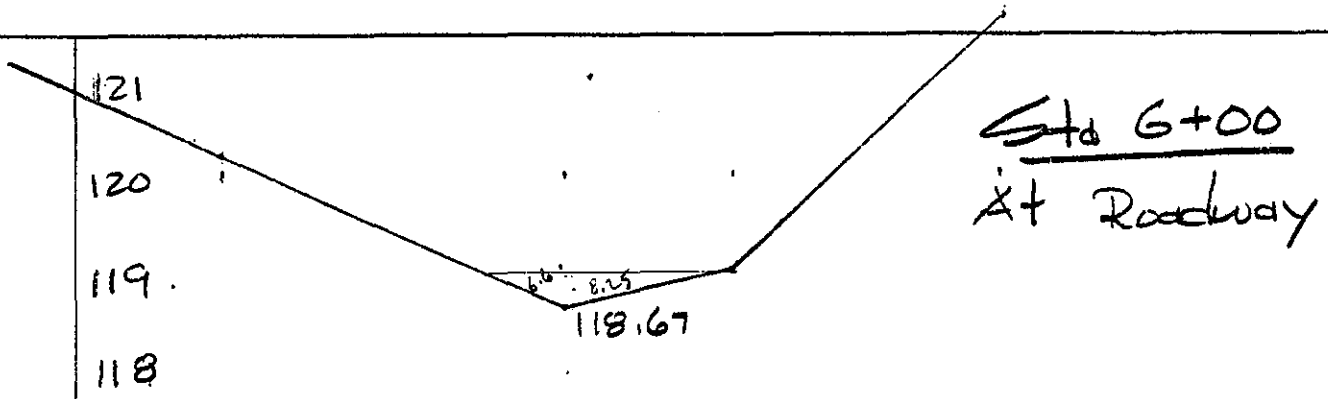
SHEET NO. 3  
 JOB DAMS  
 SUBJECT Saltun stall  
 CLIENT COE

$$V = \frac{1.486}{0.035} (R^{2/3}) (0.0038)^{1/2} = R^{2/3} (2.65)$$

<u>D</u>	<u>WP</u>	<u>Area</u>	<u>R<sup>2/3</sup> (2.65)</u>	<u>V</u>	<u>Q</u>
0.33	70'	12 sf	0.31	"	0.81 cfs
0.83	120'	52 "	0.57	"	1.51
1.33	170'	120 "	0.79	"	2.60
2.33	265	340	1.18	"	3.13

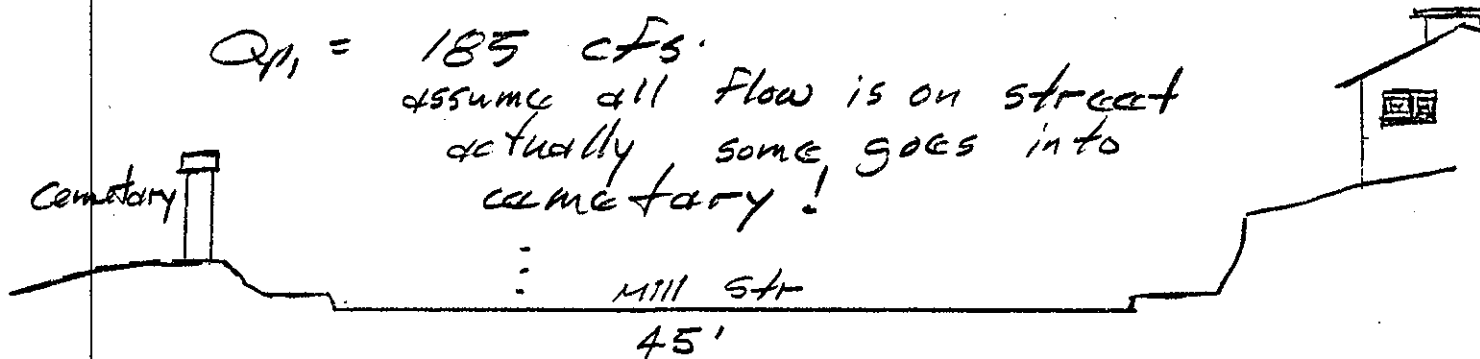
Sta 1400

$$Q_{p1} = 185 \text{ cfs}$$

assume all flow is on street  
 actually, some goes into  
 cemetery!
